# Manhole Inspection Summary

Manhole # S45Y\_\_011MH

Insp Date: **7/20/09 8:48 AM**

**Location** Address: **1901 Andre St.**

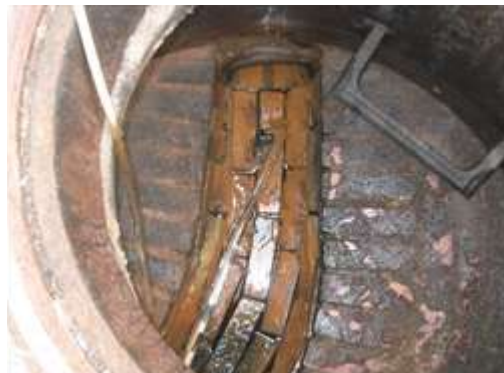
Top View

tube on left runs up through MH lid

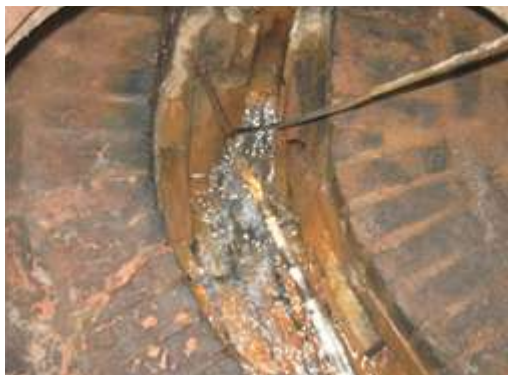
Miscellaneous

☒ **Deteriorated**

MH channel

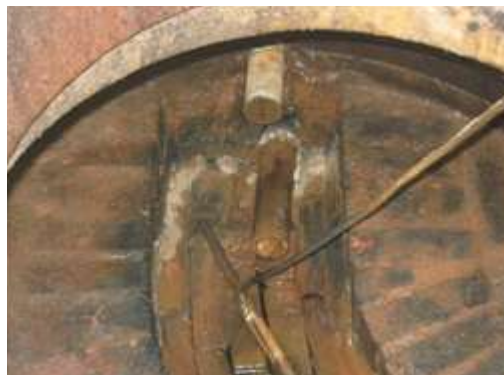
Miscellaneous

Tube running out of MH cover

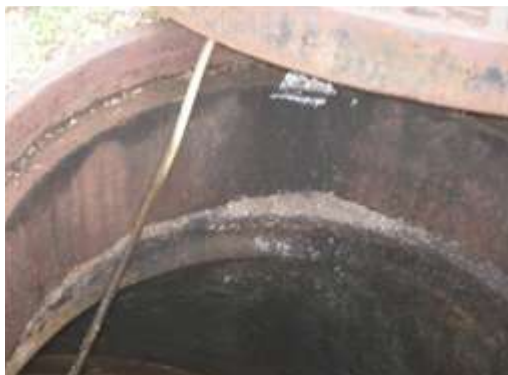
Miscellaneous

Breather tube running out of MH cover

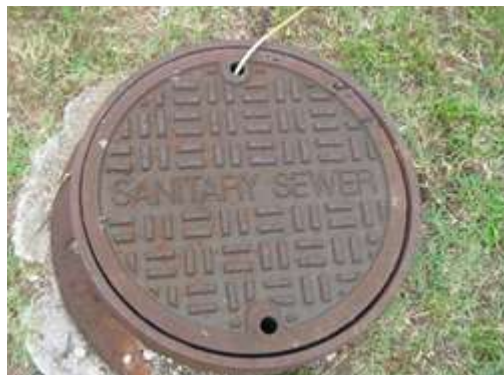
Miscellaneous

MH Cover

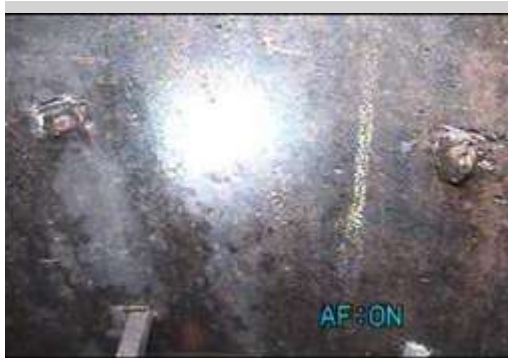
Defect 1

Missing: **1**

missing rung

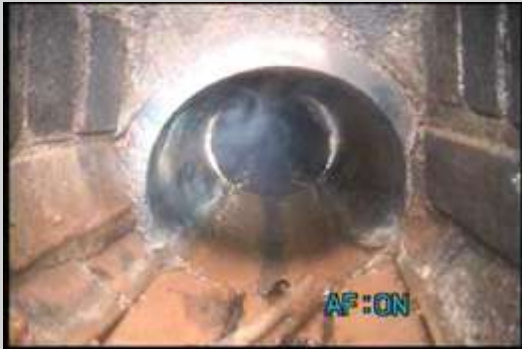
12 O'Clock Outflow

8 in. Circular Gravity Sewer  
Pipe Out @ 12 O'Clock

Infiltration: **None** Pipe Seal Cond: **Sound**

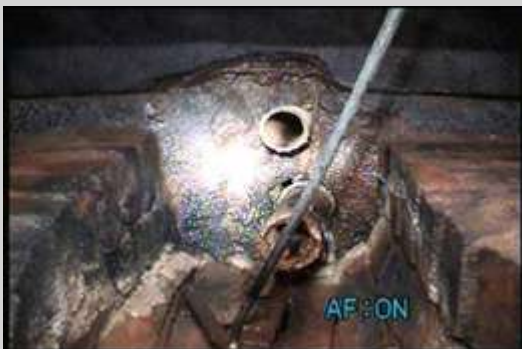
8 O'Clock Inflow

4 in. Circular Gravity Sewer  
Pipe In @ 8 O'Clock

Infiltration: **None** Pipe Seal Cond: **Sound**
